Title: Failure of the RHIC Building 1004B Valve Box

SCBNL E-01648 Date: 01 August

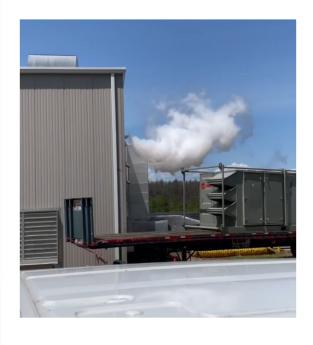
Description: At 12:31PM, August 1, a RHIC magnet quench link interlock occurred in RHIC. As a response to the quench link interlock, 12 DX magnet heaters automatically turned on and the RHIC beam was aborted. The CAD main control room contacted the cryo control room to inform them of the quench link interlock. At 12:39, the cryo control room reported to Main Control that the blue ring valve box in building 1004B was venting helium to the exterior of the building. Cryo control room started to remove helium from the RHIC blue ring. Fire/Rescue and CAD personnel responded to building 1004B. No personnel were in the building at the time of the event. Fire/Rescue swept the building and found no personnel inside the building. Building 1004B entrances were cordoned off and a perimeter established near the vent. At 3:15PM, Fire/Rescue swept the building again, found no oxygen deficiency and turned the building over to C-AD. Helium recovery efforts will continue.

- Fire/Rescue swept building for personnel. No personnel found.
- Building entrances secured.
- · Perimeter established around vent.
- Helium Recovery commences in blue ring
