iTPC LV Power Failures Analysis, Cause & Corrective Action

- Anderson Power-Pole connection failures (slides 2 – 10)
 - iRDO FEE power open fuses (slide 11)

Report By Tim Camarda for the STAR collaboration

December 2024

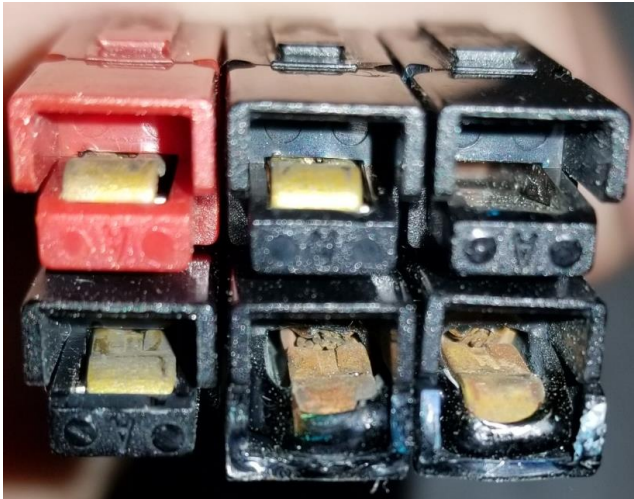
Typical overheated Anderson Power-Pole connector & contacts (iTPC LV power cable interconnect)

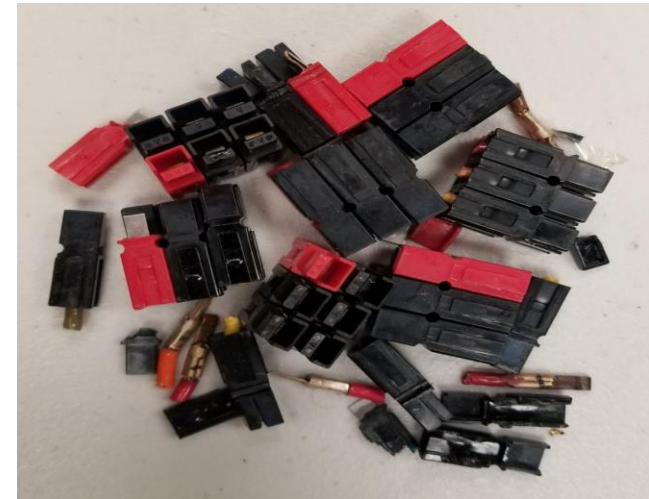
Contact housing & connector removal for typical repair of LV interconnect (parts removed from 4x sectors shown)

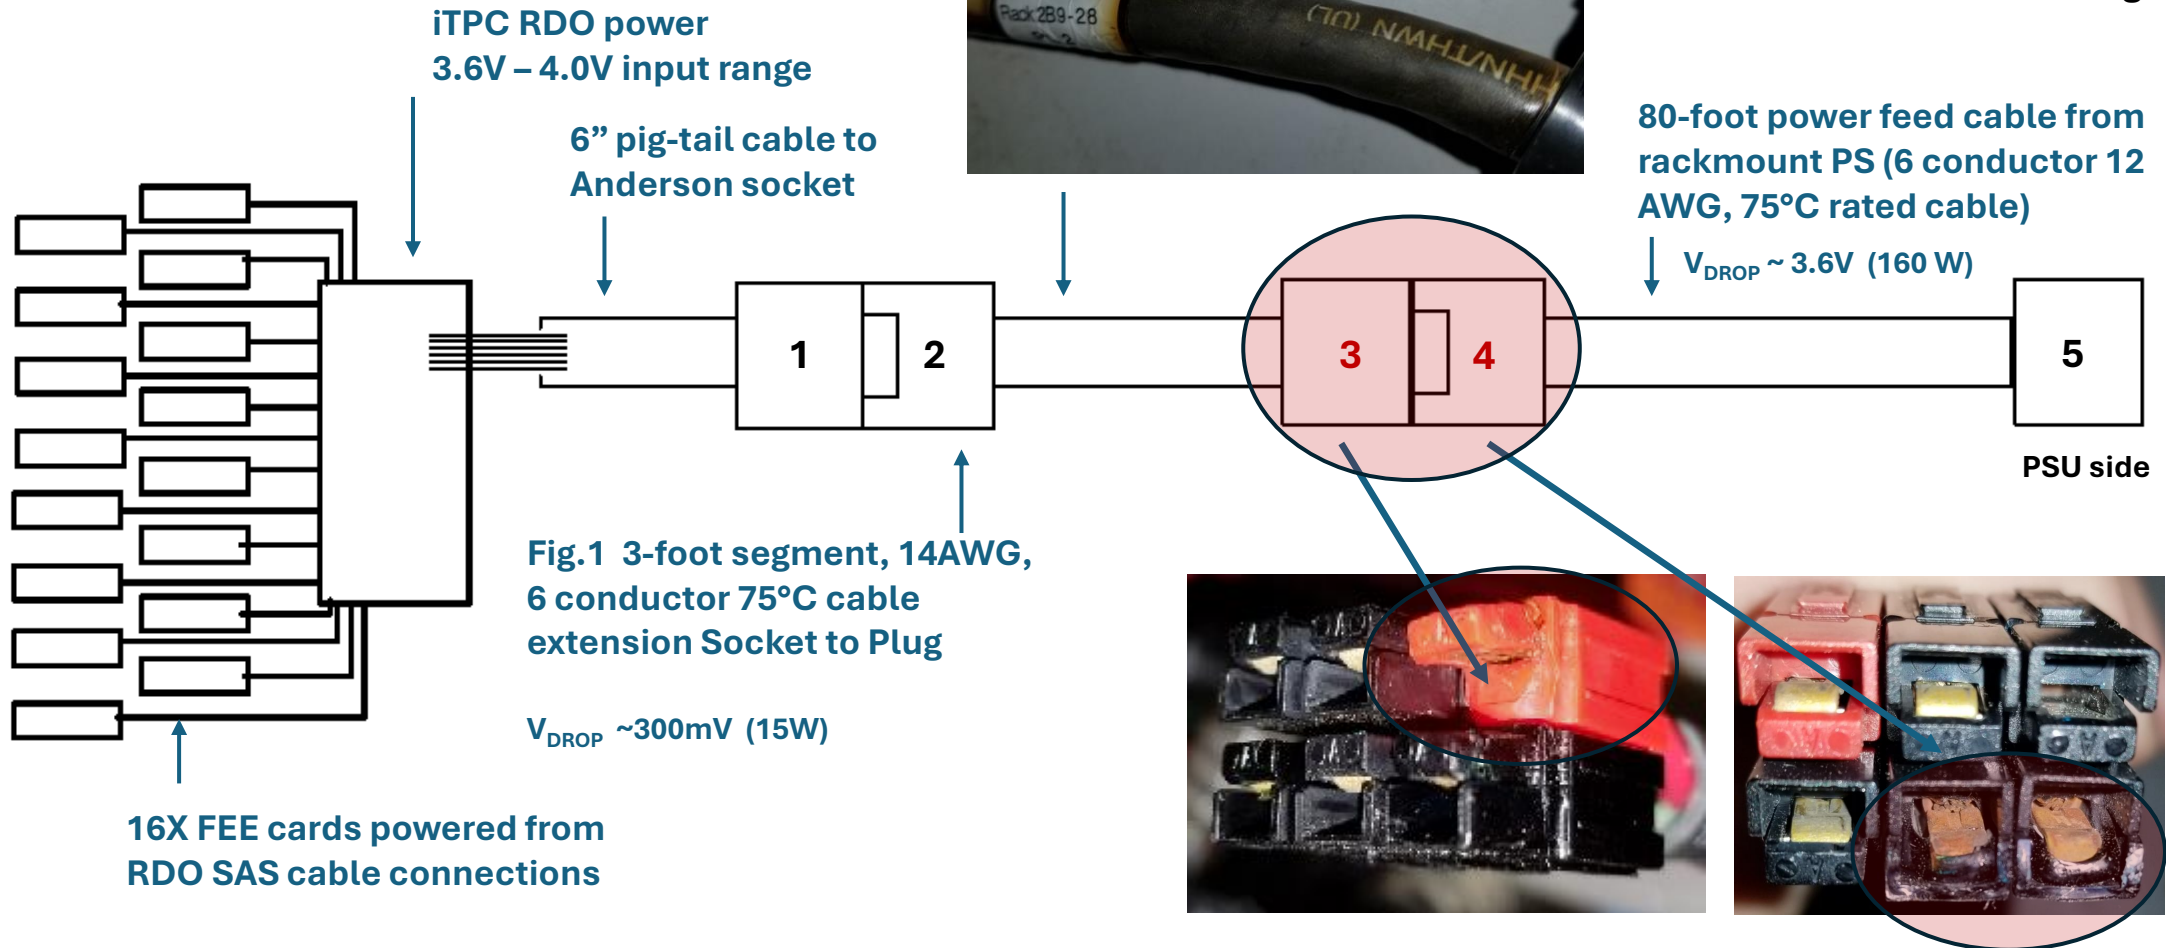
Fig.3 Socket & plug ends of 3-foot extension cable & feed cable ends Melted pin housing & overheated contacts

The power issues for the iTPC RDO + Front End electronics were found to be from degraded connections at the power feed at the detector side extension cables (**slide #3, fig 1**). The power feeds from the rack-mount power supplies are run to each clock position of the fringe of the outer TPC segments. Three-foot extension cables (**fig.1**) are then used to carry the power to each inner RDO or in the case of the TPX sectors a wye adapter cable is used to bring power to 2x RDO's. In total, there are five Anderson disconnects to each RDO.

I have also noted that the cable jacket & wiring shows signs of over-heating as well. This indicates the wire & jacket are exceeding the 75° operating rating (**slide#3 fig. 2 & slide#4 fig.5**).

Corrective Action: Replace connectors 3 & 4 (slide #3) with 14 to 12 AWG Butt-Splices

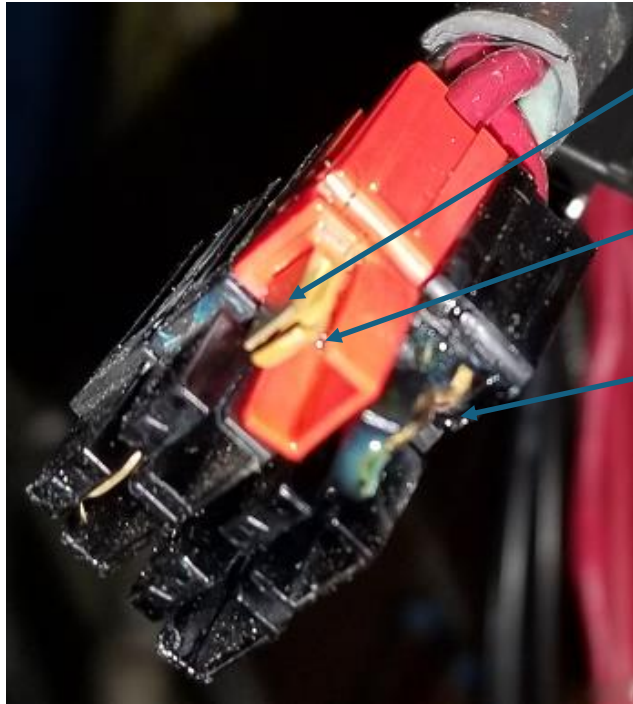
Fig.4 Metal spring for contact mating retention

Anderson power-pole connector housing & wire damage from excessive heating

Note: part of contact housing broken off

Damaged housing and contact from excessive amperage caused by heating effects

Housing is rated for 105°C

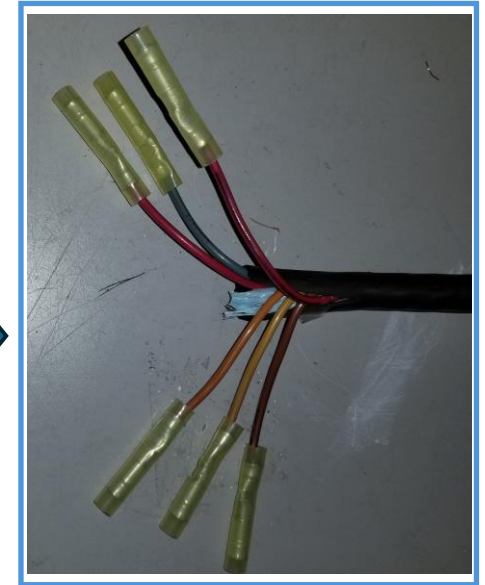
Fig.5 Burnt contacts and part of housing broke off due to excessive heat

Burnt wiring found on both the 12AWG feed and 14AWG extension

Wire & cable jacket is 75°C rated

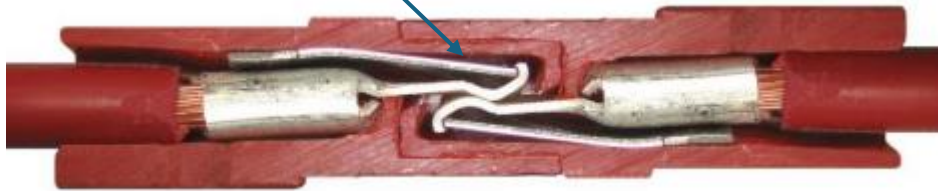
Fig. 6 Cutaway view of correct mating position of contacts inside of housing

Proper Vs Improper post-crimped pins

Contact mating force spring

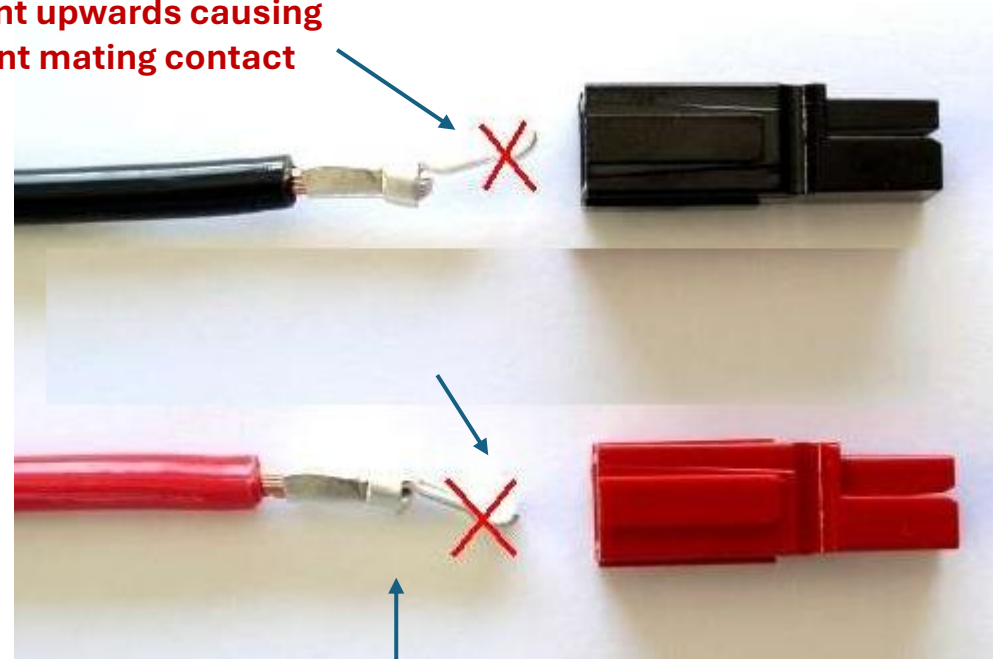
Fig. 7 Crimp bent downwards causing contact not locking into place. This causes the contact to recede too far in & will cause insufficient mating contact.

I have noted in some instances several post crimped pins that were distorted most likely by an improper crimp method. In these cases, the pins are bent in such a way that causing decreases mating force.

Distorted contacts bent during crimping process

Crimp bent upwards causing insufficient mating contact

I have noted in the case of Anderson Power-Pole connectors used in other detectors, that the condition of bent contacts (**slide 7, figure 7**) caused similar overheating. I am not 100% certain if this condition exist here for the TPC, but I have observed while removing the connector for the splice replacement...that a contact would fall out. On **slide #8 (figure 8)** we can see this condition where a contact pin for the LV return fell out (upper left corner pin) while the other contact pins remained intact.

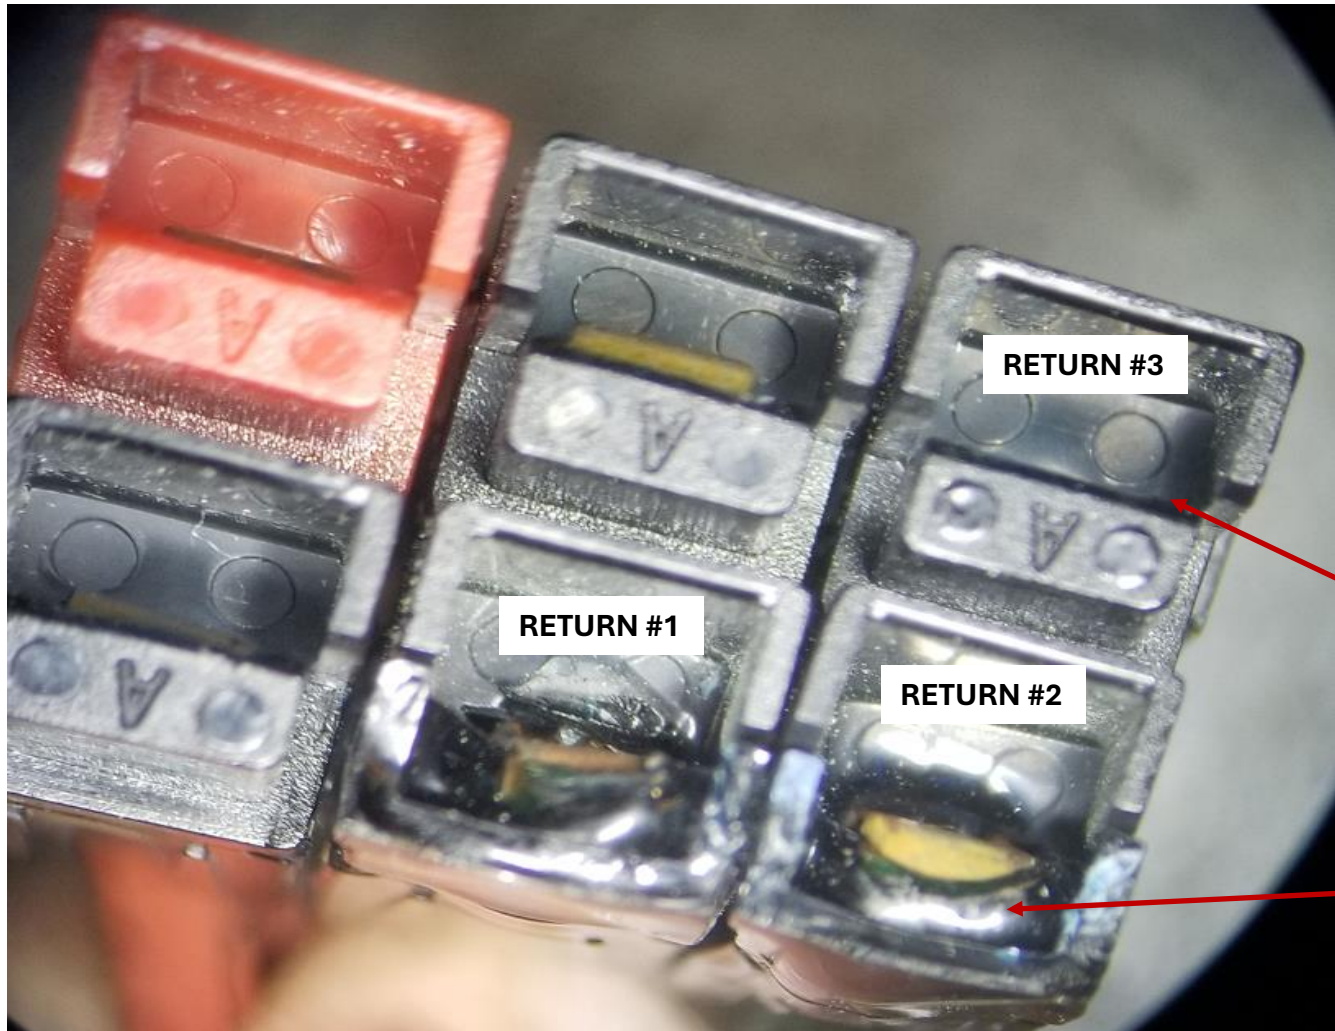
Fig.8 LV Return housing melted

Third return contact pulled out possibly due to distorted or bent crimp

Over-heated LV return connections either due to increased mating resistance or from third contact not seating correctly...causing these 2x pins to carry a 33% increase in load.

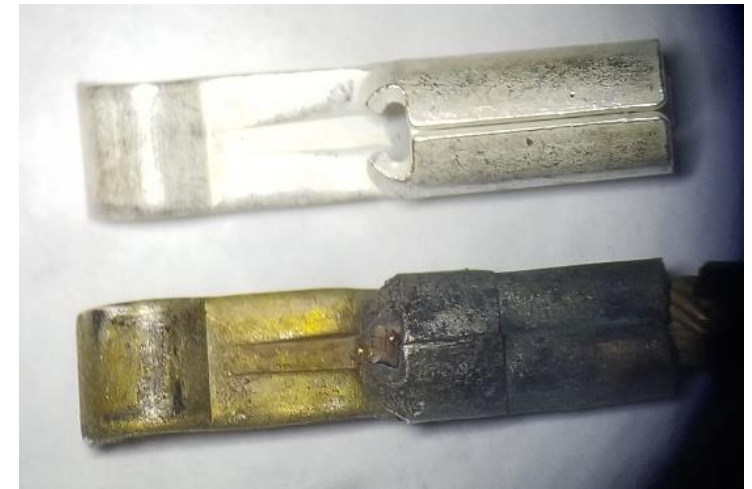
Fig.9 New contact on top Vs contact removed from the field
Contact on bottom shows signs of pitting & excessive heating

Under the assumption that only a negligible imbalance exist between connections and that each connection is solid (within the rated mating resistance specs)...The connections should be well within the rated temperature for the contacts & housing assembly (i.e. within the current rating of the contacts). However, there is a condition that is causing excessive heating on one or more of the contacts of the connector. The excessive heating is melting the polycarbonate contact housing (**slides 3-4, fig.3,4,5**). Once the housing becomes distorted, the connection will become totally degraded. Significant pitting is also noted on the contact plating which is either a sign of overheating or possibly galvanic corrosion (**slide#8, fig.9**).

I have observed even looking at pins from housings that did not melt, that it appears that the contact finish was worn off. On **slide eight, figure 9** I compare a new silver-plated contact on top with one removed from the field. It could be possible that the contacts used on the feed side Vs the three-foot extension side contacts use different plating (Tin Vs Silver). If this is true, then the discoloration and pitting on the contacts could be due to electrolysis caused by galvanic corrosion and would cause overheated connections over time.

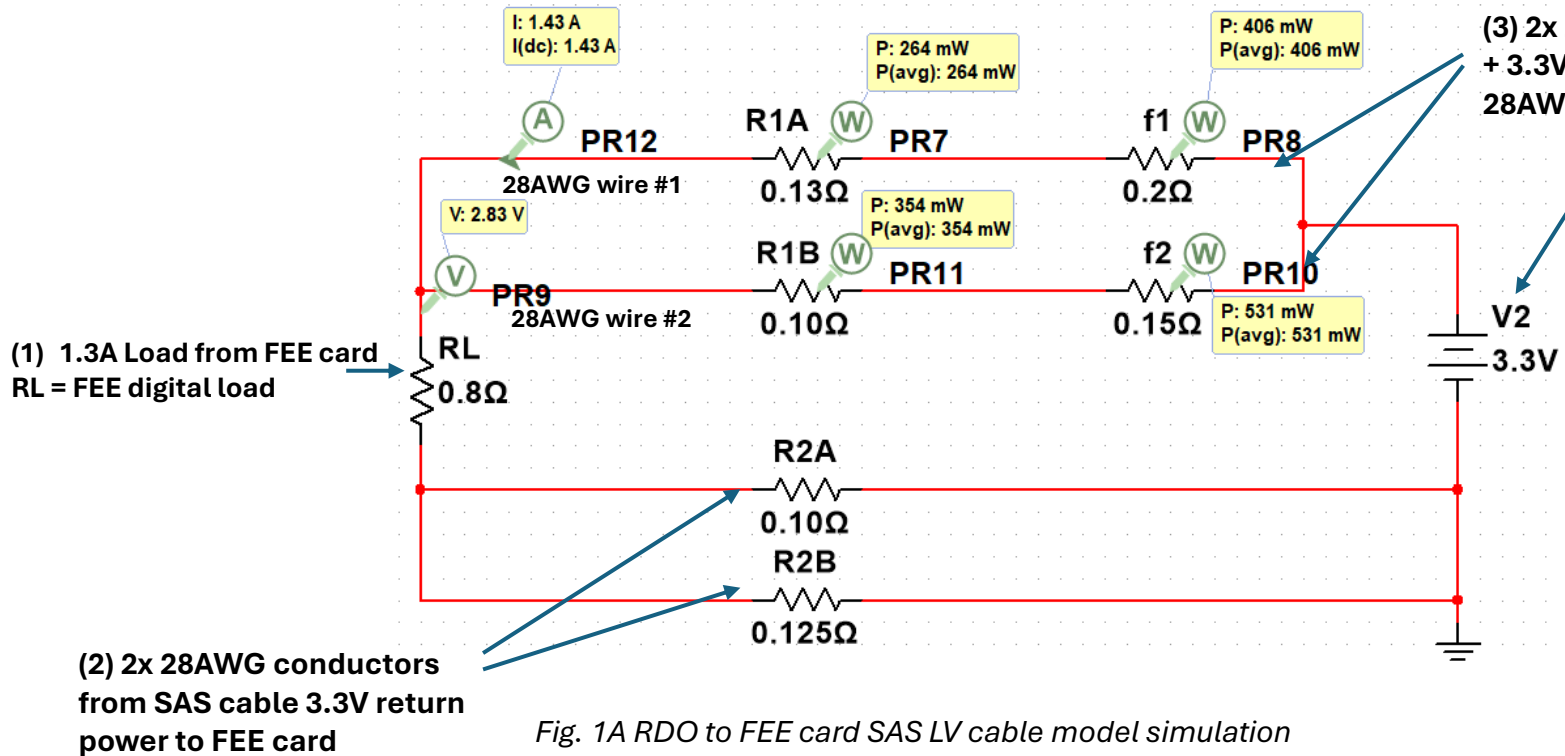
Fig. 1A RDO to FEE card SAS LV cable model simulation

Another issue exist where the fuses on the RDO that distribute power to the FEE cards are blowing. This condition occurs due to placing a separate fuse for each of the two LV positive wires from the SAS cable which essentially places the fuses in parallel...

(2) R1A, R1B, R2A, R2B includes cable resistance + contact mating resistance variations

Fuse & contact resistance can vary as much as 20%

In this example: Due to the imbalance caused by placing the fuses in parallel, f2 will see a greater power drop. This will cause a gradual but steady climb in operating temperature which can eventually cause the fuse to open.

Power on surge current can also cause this condition, due to imbalance in voltage drop.

Note: f1 and f2 are 1.0A rated fast blow fuse

It is typically better & accepted to tie both connections at PCB and use a single fuse for both conductors.

Corrective action: Bridge connection at RDO PCB (left side of f1 & f2) & replace with single 2.5A fast fuse or 2A slow blow.
