iTPC LV Power Failures Analysis, Cause & Corrective Action

- Anderson Power-Pole connection failures (slides 2 – 10)
 - iRDO FEE power open fuses (slide 11)

Report By Tim Camarda for the STAR collaboration

December 2024

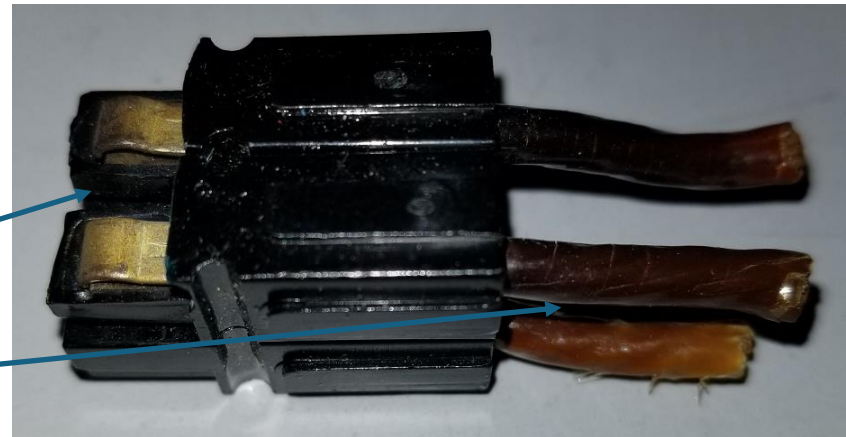
I have also noted that the cable jacket & wiring shows signs of over-heating as well. This indicates the wire & jacket are exceeding the 75° operating rating (**slide#3 fig. 2 & slide#4 fig.5**).

Fig.5 Burnt contacts and part of housing broke off due to excessive heat

Burnt wiring found on both the 12AWG feed and 14AWG extension

Wire & cable jacket is 75°C rated

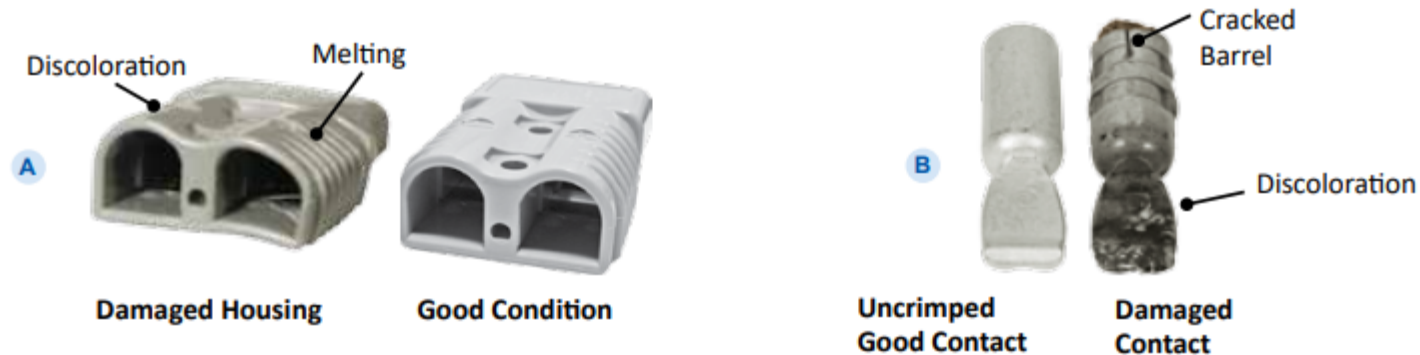
2020-0055 Preventative Maintenance REV C7

- A. Examine the crimp between cable and contact. Ensure the crimp tooling recommended by Anderson™ has been used. Improper crimping, corrosion, and broken wires result in unnecessary resistance causing the contact to heat up.
- B. Check contact surfaces for signs of “pitting” caused by dirt or disengaging connectors under load. One badly pitted contact, particularly in a connector attached to a battery charger, can lead to pitting on surfaces of other contacts. If not corrected, this can result in an epidemic of bad connectors throughout a fleet of electric vehicles and in chargers and batteries.
- C. Check to see if batteries are being disconnected while the charger is still on. This causes the contacts to arc at the tips, resulting in progressive pitting and silver removal from tip to crown. If this practice is occurring, it should be discontinued to avoid major repairs in the future.

If any of the following conditions exist, the connector housing, contact and / or cable should be replaced immediately.

- A. Housing - Cracks, missing pieces, evidence of excessive heat, discoloration. You may consider replacing the existing housing with a Chemical Resistant equivalent for improved durability against UV rays and common solvents and hydrocarbons.
- B. Contacts - Pitting, burns, corrosion, excessive wear and cracked crimp barrels, as shown in image "B".
- C. Cable - Exposed copper near housing, cracked cable, peeling or frayed insulation.
- D. Handles - Loose attachment and signs of damage as missing or loose hardware and cracked or broken plastic (Handles should be used for connectors that are hard to reach or move).
- E. Cable Clamps - Loose attachments, signs of abraded cable jacket, missing or loose hardware. (Cable clamps should be used to relieve strain on unmounted cable).
